Optimizing Blade Performance to Ensure Post Warranty Turbine Availability

Topic: Operating Wind Project Post Warranty
Prepared For: AWEA – Windpower 2009
Author: Chris Wraith
Date: April 20th, 2009
Acknowledgements: Jenny Jeffrey
Mike Jeffrey

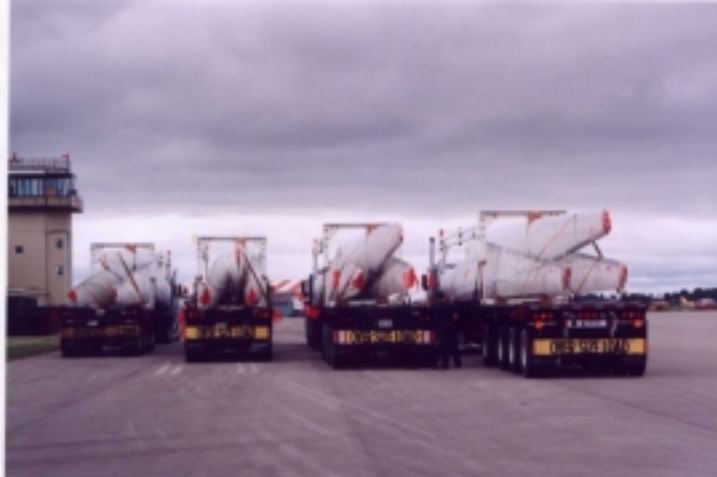
Figure 1 - Transport of Blade Sets

Once the blades arrive on-site they must be inspected. Exterior inspections of all blades are required to determine if any transportation damage has occurred. OEM's will need to have blade repair crews available on-site to repair any transportation damage, or other damage discovered during these inspections. On-site crews will limit the time required for completing the repairs thereby limiting delays during the site construction, and reducing costs. As well, blade repair crews will ensure that all of the blades are correctly matched in their sets. Incorrectly matched blade sets will lead to avoidable vibrations and decreased turbine performance.

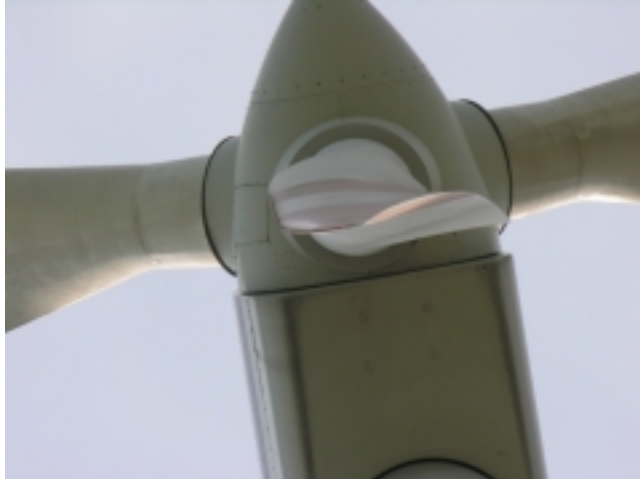
Figure 2 - Aerodynamic Alignment Photograph

Aerodynamic alignment inspections involve inspections for Cone Angle, Partition Angle, Blade Contour and Twist and Angle of Attack. Cone Angle refers to the angle that the blades are located with reference to the turbines tower. Partition Angle refers to the blade angle spacing with respect to each other. Angle of Attack refers to the angle between the blade profile chordline and the rotor plane. Faulty angles will lead to increased vibrations and decreased turbine operating efficiency. Once these measurements are completed, and corrective actions taken if required, the results need to be documented and will serve as benchmarks for future inspections.

If blades must be removed from the rotor to complete the repairs, it is recommended that both Aerodynamic Alignment and Dynamic Balancing of the rotor be completed. This alignment and balancing will decrease the overall vibrations of the turbine, increasing the lifespan of the turbine's individual components, and operating efficiency. Repairs completed with the blades still on the rotor may also require that the rotor be Dynamically Balanced. Minor repairs at the tip, due to the size of the blades can result in a large mass imbalance.

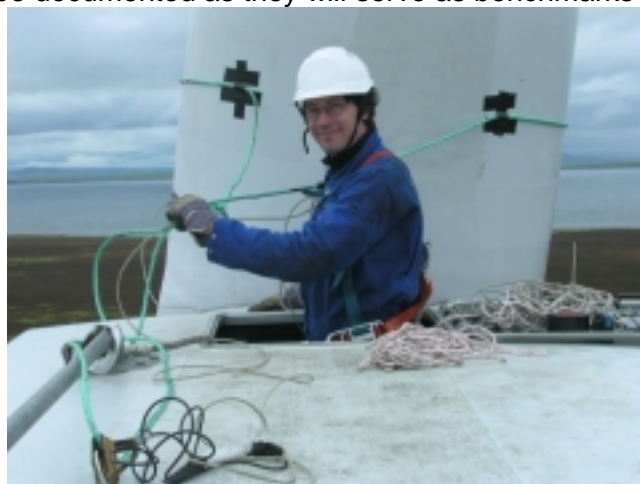
Figure 3 - Dynamic Balancing Set-up

Dynamic balancing involves comparing the turbine operating vibration levels with and without a known mass imbalance on the rotor. The results are then used to determine the magnitude of the dynamic mass imbalance of the turbine. In the event of an imbalance, mass is added to the lighter blade(s) as required to balance the rotor. Allowable imbalances will be defined by OEM. These results need to be documented as they will serve as benchmarks for future inspections.

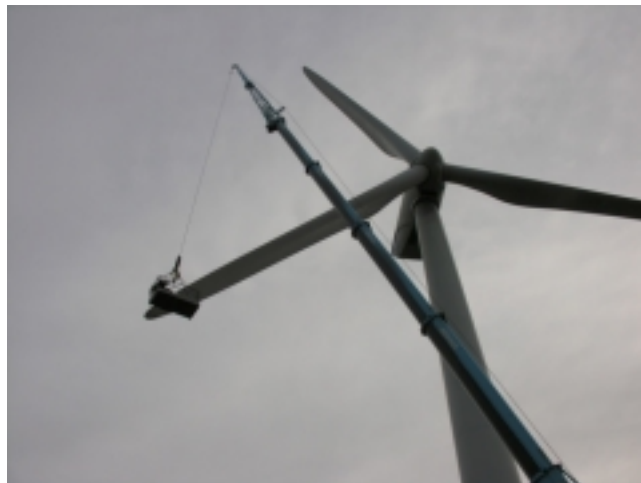
Figure 4 - Man Basket suspended from Crane

To do preliminary visual inspections of the exterior of the blades, inspectors commonly use field glasses from either the ground or the top of nacelle. The nacelle is generally preferred as the inspector is closer to the high stress areas of the blade, the root and the transition area. Trained inspectors will be able to identify areas of concern while they are still small. The following equipment can be used to investigate the areas of concern while the blades are still on the tower:

1. Man-Basket from Crane
2. Suspended Access Platforms
3. Rope Teams suspended from the Nacelle
4. Truck Mounted High Access Aerial Lift

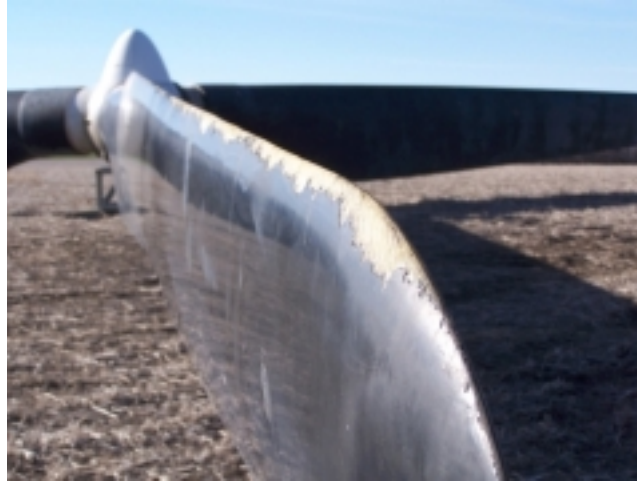
Figure 6 - LE Erosion

Fine dirt and dust particles act similar to sand in a sand blasting operation. With blade tip speeds on some turbines in excess of 70m/s, erosion of the blades Leading Edge (LE) is a common occurrence. If this damage is not repaired blade aerodynamic efficiency will be directly affected. This erosion also exposes the fibreglass laminate to UV radiation, degrading the laminates mechanical properties. Additionally, it simplifies the path for water absorption, also

degrading mechanical properties. LE Erosion can be easily monitored through routine visual inspections.

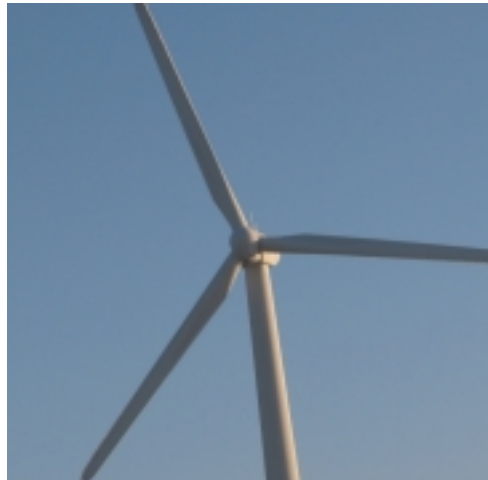
Figure 7 - Ice on Blades

Ice accumulation on the surface of blades will drastically affect their aerodynamic efficiency and can produce large mass imbalances. Turbines should not be allowed to run with ice on the blades, and typically won't, due to the large vibrations that form. Blades have buckled due to the additional load imparted by the ice.

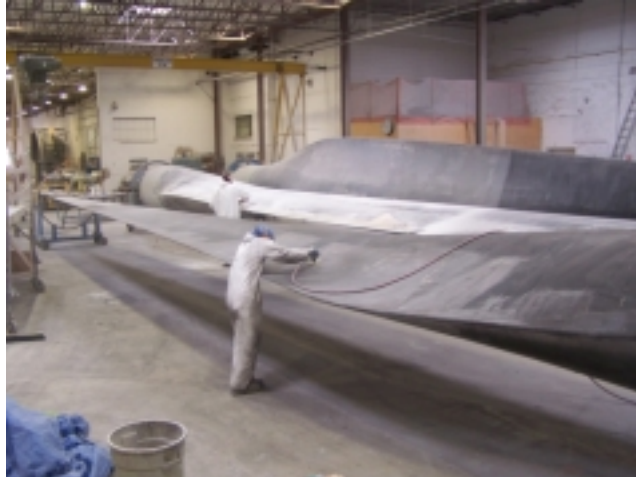
Figure 9 - Off-Site Repair

On-turbine repairs are generally the most cost-effective solution, especially when scheduled as part of the site wide inspections and maintenance. However, this solution is generally limited to minor repairs. On-site on the ground repairs are simpler and safer to complete and can be more extensive, however, they are still subject to many of the same environmental concerns as on-turbine repairs. Some of these concerns can be offset by constructing temporary tents. Large and very extensive repairs must be done at an Off-Site Repair Facility. Depending on the frequency of the required repair, such as a product wide refurbishment program, the required scale of the repairs may dictate that a central repair facility will be more economical than sending satellite teams to individual sites.

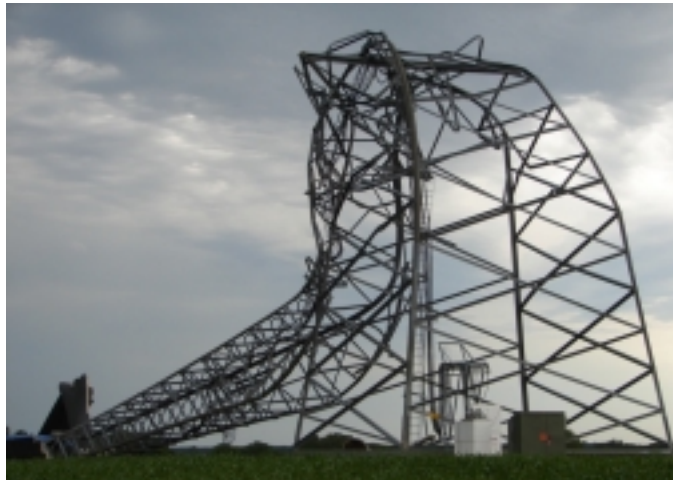
Figure 10 - Catastrophic Turbine Failure

If following the inspection, required repairs are not completed, dire consequences may occur. This may also occur if the Owners and Operators feel that an Inspection and Maintenance Program is not required, or not correctly implemented. Experience has proven that absent or ineffective inspection and maintenance programs will severely decrease the operating life expectancy, power performance and availability of the Wind Turbine. Catastrophic Rotor Blade and/or Turbine failures have been known to occur.
